## SAFETY NOTICE MANDATORY ACTION REQUIRED

**SUBJECT:**
**- SAFETY HARNESS ATTACHMENT POINTS USED AS AN ANCHORAGE POINT FOR TRANSPORT**

**DATE OF ISSUE MAY 2ND, 2023**

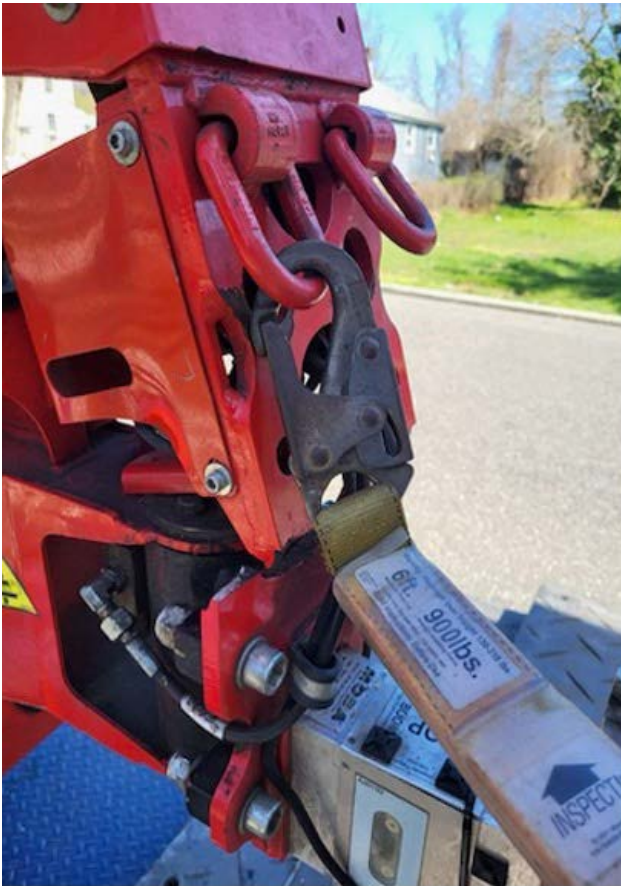
*Picture 1*

**CMC has been notified of cases of safety harness attachments points used to secure the machine to trailers and trucks for transport purposes.(picture 1 and picture 2)**

- The improper use of the safety belts anchorage points to secure the machine during transport has caused the breakage of the basket bracket (picture 1 and picture 2) and can lead to serious injury or death.

- IMMEDIATELY STOP USE THE SAFETY HARNESS ANCHORAGE (*picture 1 and 2*) TO SECURE THE MACHINE FOR TRANSPORT PURPOSES.
- OWNERS AND USERS MUST IMMEDIATELY INSPECT THE SAFETY HARNESS ANCHORAGE POINT AND THE ENTIRE STRUCTURE OF THE LIFT.
- THE IMPROPER USE OF THE SAFETY BELTS ANCHORAGE POINTS TO SECURE THE MACHINE DURING TRANSPORT HAS CAUSED THE BASKET BRACKET TO BREAK AND CAN LEAD TO SERIOUS INJURY OR DEATH.
- ALWAYS READ AND FOLLOW ALL INSTRUCTIONS IN THE SERVICE AND MAINTENANCE MANUAL AND THE OWNER'S MANUAL.

**ACTION:** The owner must inspect their equipment and check for any possible damage to the basket bracket and on the entire lift structure as per Picture 1, 2, 3 and 4.

If the inspection reveals any damage to the basket bracket as specified in picture 1, 2 and 3 or any other spot on the lift structure, the owner **MUST** stop any use of the lift immediately and contact a Dealer or CMC directly.
